**Flood Control Project Maintenance
Levee Inspections**
LMA District Cover Sheet
Spring 2018 Levee Inspection Results

Reclamation District No. 1500 Sutter Basin

Spring 2018 Levee Inspection Results

Waterway			Bank	Unit Miles
Unit No. 01 Sacramento River			Left	33.15
	Spring (March - May)	Summer (June - August)	(September - November) Fall	Winter (December - February)
Unit Maintenance Rating (Fall Only)				
Date of Inspection	3/27/2018 - 3/28/2018			
DWR Inspector	Zach Jojola			
Accompanied By	Hiromi Tomita RD 1500

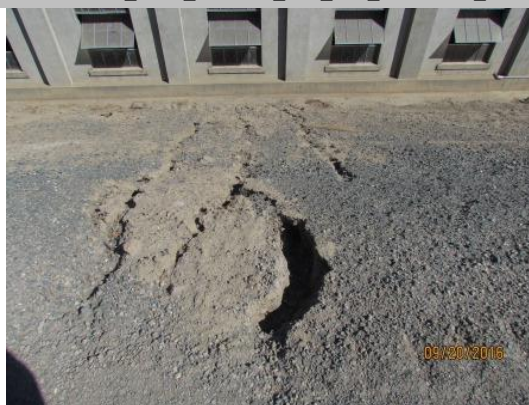
Photo 1 of 1 : SP_2018_RD1500_189_106_20180306_00053.jpg

LM Start	32.99	Rating **	A/W	Issue No.	106
LM End	32.99	Issue Type +	Ma	Location *	LS
Category	Earthen Levee			GPS Latitude/Longitude	
				Start	End
Item	Erosion / Bank Caving			39.021016 °	39.021016 °
				-121.820261 °	-121.820261 °
DWR ID	DWR_RD1500_01_f_2016_106				
Comment Code					
E2 : Schedule repair of erosion site prior to the next inspection.					
Inspector Comment

View of erosion site on LS slope of the levee. Fall 2016.

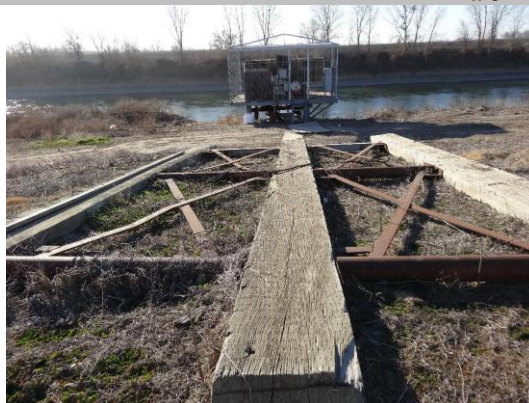
Photo 1 of 3 : UCIP_SP_2018_28953_53256.jpg

WS view: slant pumps on steel platform in shed on berm.

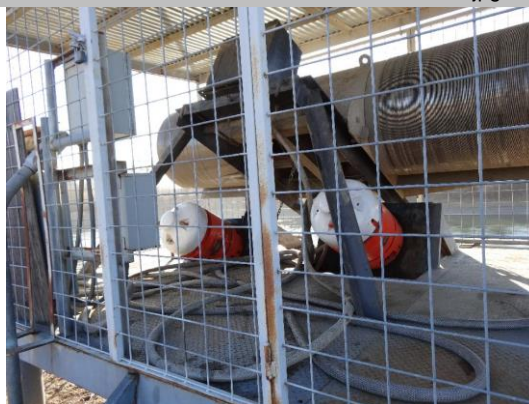
Photo 2 of 3 : UCIP_SP_2018_28953_53255.jpg

WS view: closer view of slant pumps on steel platform in shed on berm.

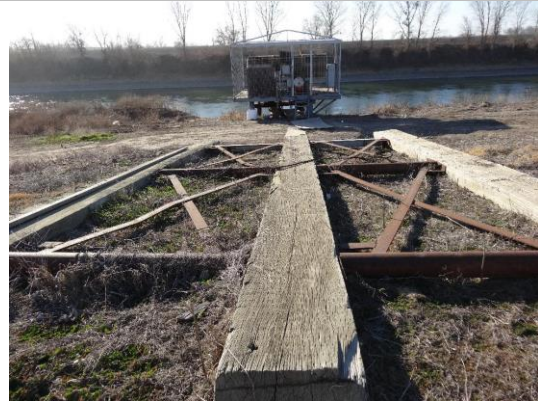
Photo 1 of 3 : UCIP_SP_2018_28952_53249.jpg

WS view: pump platform and shed on levee berm.

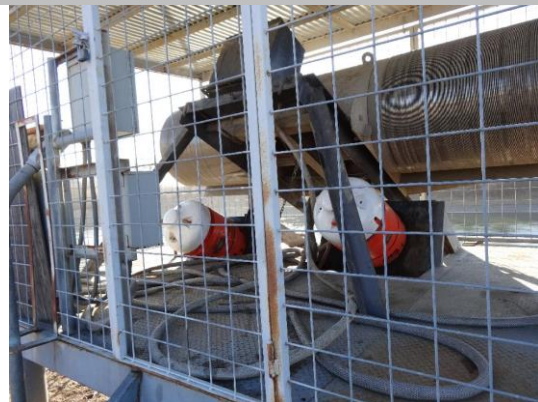
Photo 2 of 3 : UCIP_SP_2018_28952_53248.jpg

WS view: two slant pumps on steel platform at waterside berm.

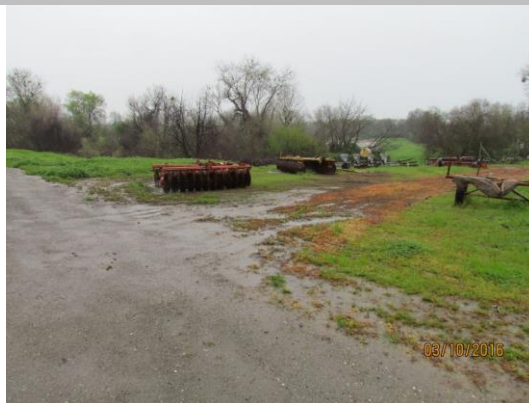
Photo 1 of 1 : SP_2018_RD1500_190_12_20180306_00005.jpg

LM Start	0.00	Rating **	M	Issue No.	12
LM End	0.00	Issue Type +	En	Location *	WS
Category	Earthen Levee			GPS Latitude/Longitude	
				Start	End
Item	Encroachments			38.761121 °	38.761121 °
				-121.674592 °	-121.674592 °
DWR ID	DWR_RD1500_02_s_2012_12				
Comment Code					
EQ : Equipment					
Inspector Comment

View of the equipment on the levee crown looking upstream. Spring 2016.

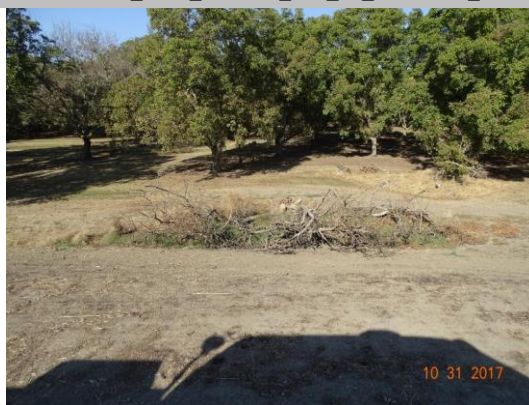
Photo 1 of 1 : SP_2018_RD1500_190_38_20180306_00009.jpg

LM Start	0.07	Rating **	M	Issue No.	38
LM End	0.07	Issue Type +	En	Location *	LS
Category	Earthen Levee			GPS Latitude/Longitude	
				Start	End
Item	Encroachments			38.761754 °	38.761754 °
				-121.673780 °	-121.673780 °
DWR ID	DWR_RD1500_02_f_2017_38				
Comment Code					
TR : Tree or limb					
Inspector Comment					
Fallen tree at landside toe.

View of tree at landside toe. Fall 2017.

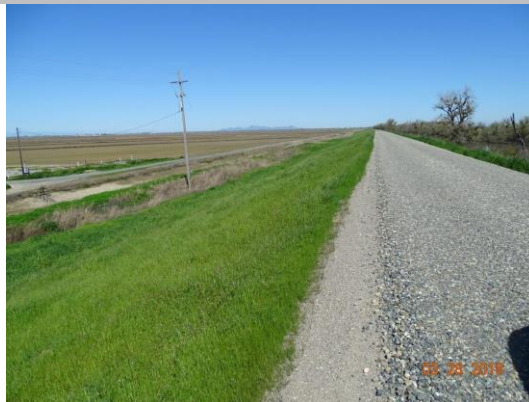
Photo 1 of 1 : SP_2018_RD1500_190_16_20180329_00041.jpg

LM Start	0.07	Rating **	M	Issue No.	16
LM End	9.97	Issue Type +	Ma	Location *	LS
Category	Earthen Levee			GPS Latitude/Longitude	
				Start	End
Item	Vegetation			38.761838 °	38.895132 °
				-121.673713 °	-121.636992 °
DWR ID	DWR_RD1500_02_s_2018_16				
Comment Code					
V1 : Control annual grass and weeds on the levee slopes and easements.					
Inspector Comment

View of vegetation on the landside slope. Spring 2018.

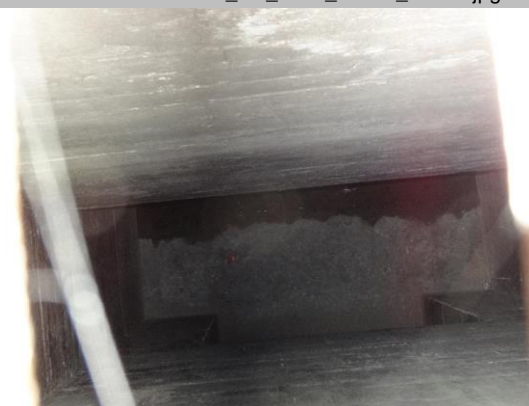
Photo 3 of 3 : UCIP_SP_2018_28892_53145.jpg

WS view: inside view of concrete box on levee shoulder.

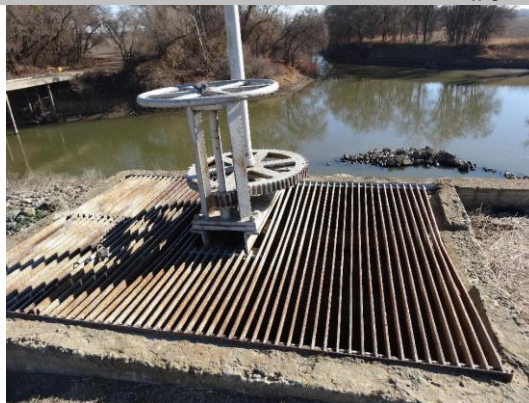
Photo 1 of 3 : UCIP_SP_2018_28893_53157.jpg

LM Start	1.99	Rating **	A/W	Issue No.	52 (cont)
LM End	1.99	Issue Type +	Ma	Location *

WS view: slide gate in concrete box on levee shoulder.

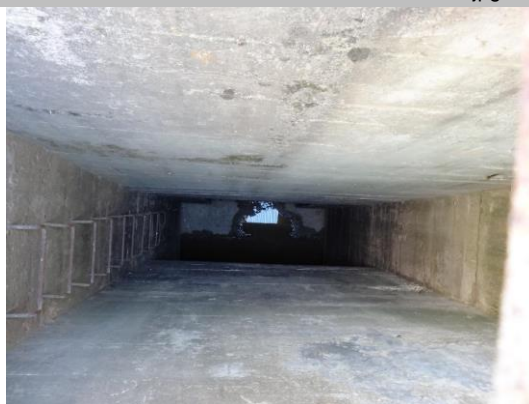
Photo 2 of 3 : UCIP_SP_2018_28893_53156.jpg

WS view: inside view of concrete box on levee shoulder.

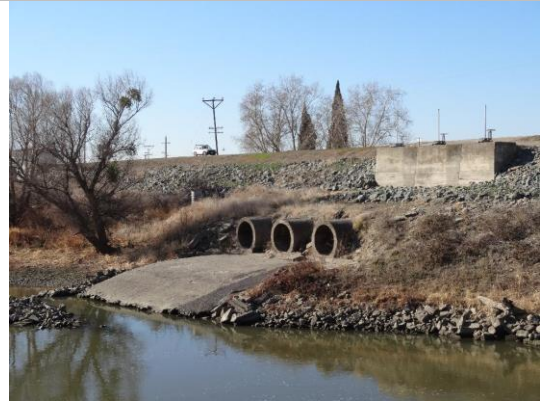
Photo 3 of 3 : UCIP_SP_2018_28893_53155.jpg

WS view: outfall structure on levee toe and concrete box on levee shoulder.

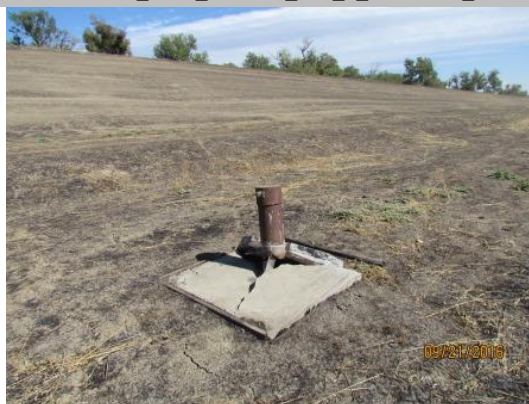
Photo 1 of 3 : SP_2018_RD1500_190_4_20180306_00001.jpg

LM Start	14.13	Rating **	U	Issue No.	4
LM End	14.13	Issue Type +	Ma	Location *	LS
Category	Earthen Levee		GPS Latitude/Longitude		
			Start	End	
Item	Underseepage Relief Wells		38.947628 °	38.947628 °	
			-121.669764 °	-121.669764 °	
DWR ID	DWR_RD1500_02_s_2012_4				
Comment Code					
Inspector Comment					
Concrete pad and PVC underneath is broken.

View of underseepage relief well. Concrete pad as well as PVC pipes underneath are destroyed apparently by an attempt to pull out the head of the well. Fall 2016.

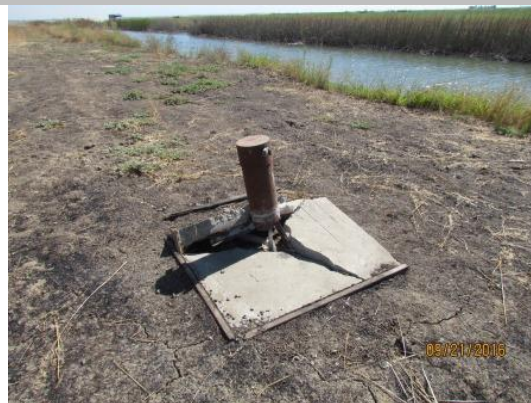
Photo 2 of 3 : SP_2018_RD1500_190_4_20180306_00002.jpg

LM Start	14.13	Rating **	U	Issue No.	4 (cont)	
LM End	14.13	Issue Type +	Ma	Location *	LS	
Category	Earthen Levee			GPS Latitude/Longitude		
				Start		End
Item	Underseepage Relief Wells			38.947628 °	38.947628 °	
				-121.669764 °	-121.669764 °	
DWR ID	DWR_RD1500_02_s_2012_4					
Comment Code						
Inspector Comment						
Concrete pad and PVC underneath is broken.

Another view of damaged well. Fall 2016.

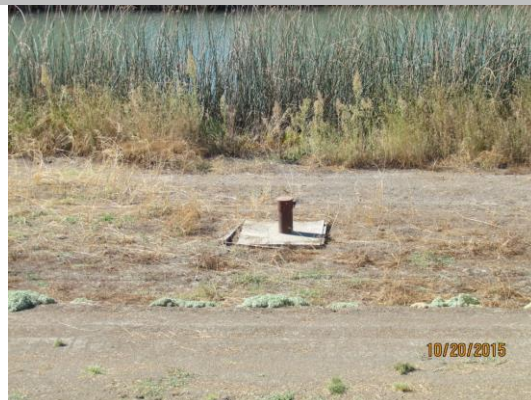
Photo 1 of 1 : SP_2018_RD1500_190_11_20180306_00004.jpg

LM Start	14.47	Rating **	A/W	Issue No.	11
LM End	14.47	Issue Type +	Ma	Location *	LS
Category	Earthen Levee			GPS Latitude/Longitude	
				Start	End
Item	Underseepage Relief Wells			38.951413 °	38.951413 °
				-121.673856 °	-121.673856 °
DWR ID	DWR_RD1500_02_s_2012_11				
Comment Code					
Inspector Comment

A relief well at historical boil 16. Fall 2015.

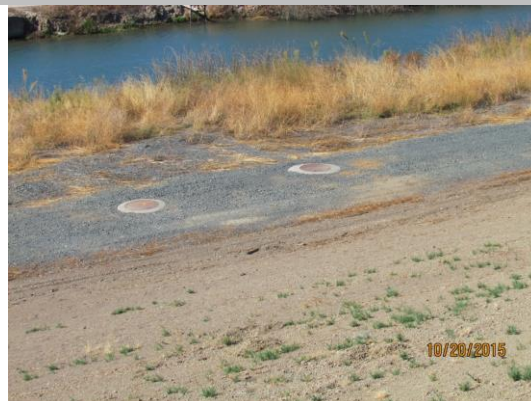
Photo 1 of 2 : SP_2018_RD1500_190_13_20180306_00006.jpg

LM Start	18.17	Rating **	A/W	Issue No.	13
LM End	18.17	Issue Type +	Ma	Location *	LS
Category	Earthen Levee			GPS Latitude/Longitude	
				Start	End
Item	Underseepage Relief Wells			38.987031 °	38.987031 °
				-121.725049 °	-121.725049 °
DWR ID	DWR_RD1500_02_s _ 2012_13				
Comment Code					
Inspector Comment

Two of four drains on the landward side of the levee. Fall 2015.

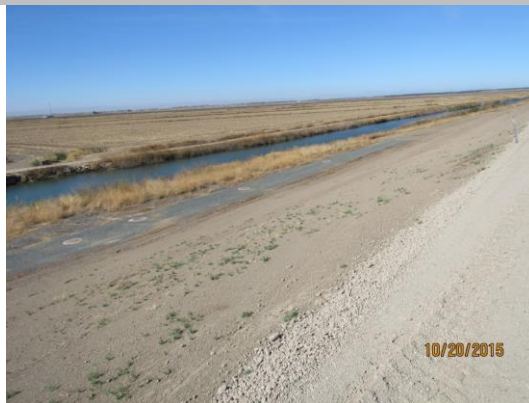
Photo 2 of 2 : SP_2018_RD1500_190_13_20180306_00007.jpg

LM Start	18.17	Rating **	A/W	Issue No.	13 (cont)	
LM End	18.17	Issue Type +	Ma	Location *	LS	
Category	Earthen Levee			GPS Latitude/Longitude		
				Start		End
Item	Underseepage Relief Wells			38.987031 °	38.987031 °	
				-121.725049 °	-121.725049 °	
DWR ID	DWR_RD1500_02_s_2012_13					
Comment Code						
Inspector Comment

View of the 4 drains at the levee toe on the landward side. Fall 2015.

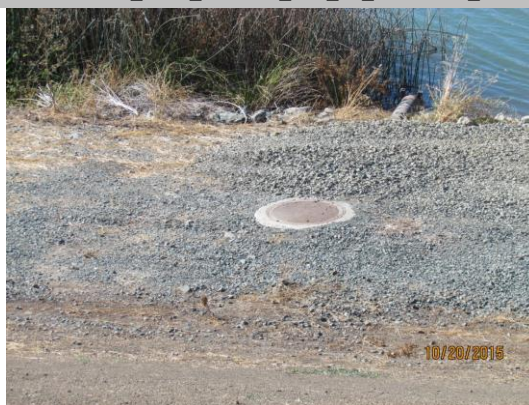
Photo 1 of 1 : SP_2018_RD1500_190_15_20180306_00008.jpg

LM Start	18.43	Rating **	A/W	Issue No.	15
LM End	18.43	Issue Type +	Ma	Location *	LS
Category	Earthen Levee			GPS Latitude/Longitude	
				Start	End
Item	Underseepage Relief Wells			38.989962 °	38.989962 °
				-121.727896 °	-121.727896 °
DWR ID	DWR_RD1500_02_s_2015_15				
Comment Code					
Inspector Comment

View of the toe drainage at the landward toe berm. Fall 2015.
